**NASA Contractor Report 159261**

VISUALIZATION OF IMPACT DAMAGE OF COMPOSITE  
PLATES BY MEANS OF THE MOIRÉ TECHNIQUE

W. G. Knauss, C. D. Babcock,  
and H. Chai

NASA Grant NSG-1483  
April 1980

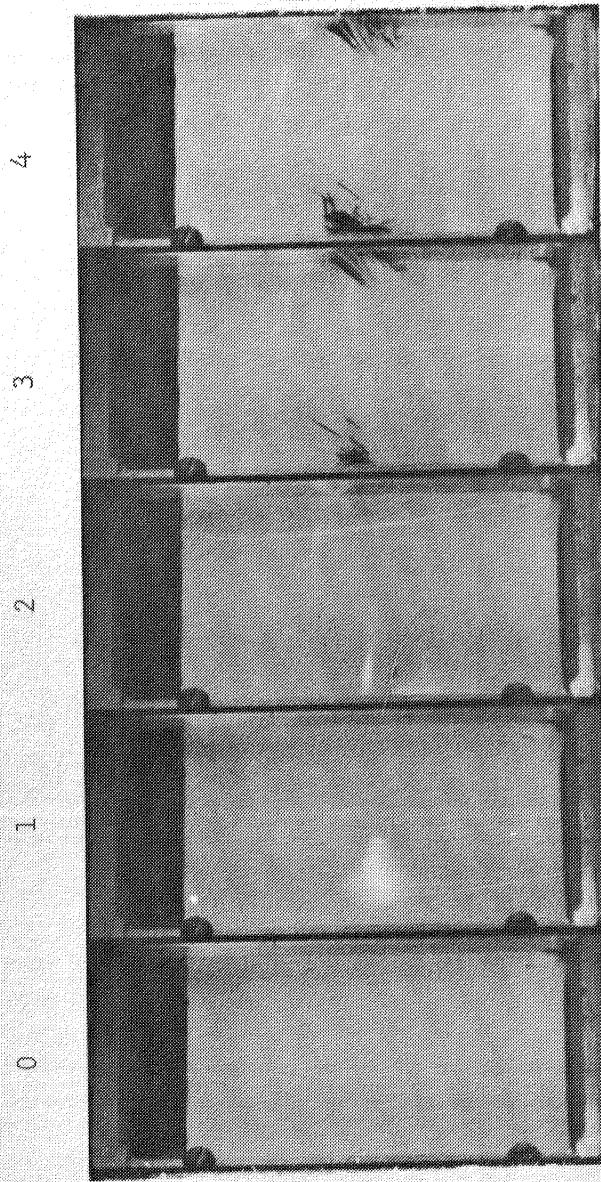
The first tests were conducted using reflected light photography. Test panel A-2 is shown in fig. 7. The time between frames is 110  $\mu$ s. Frame one of this sequence shows what appears to be a bulge in the surface. Extensive damage in the region near the edge is evident in the next frames.

Fig. 7 Test Panel A-2, 9,000 frames/sec.

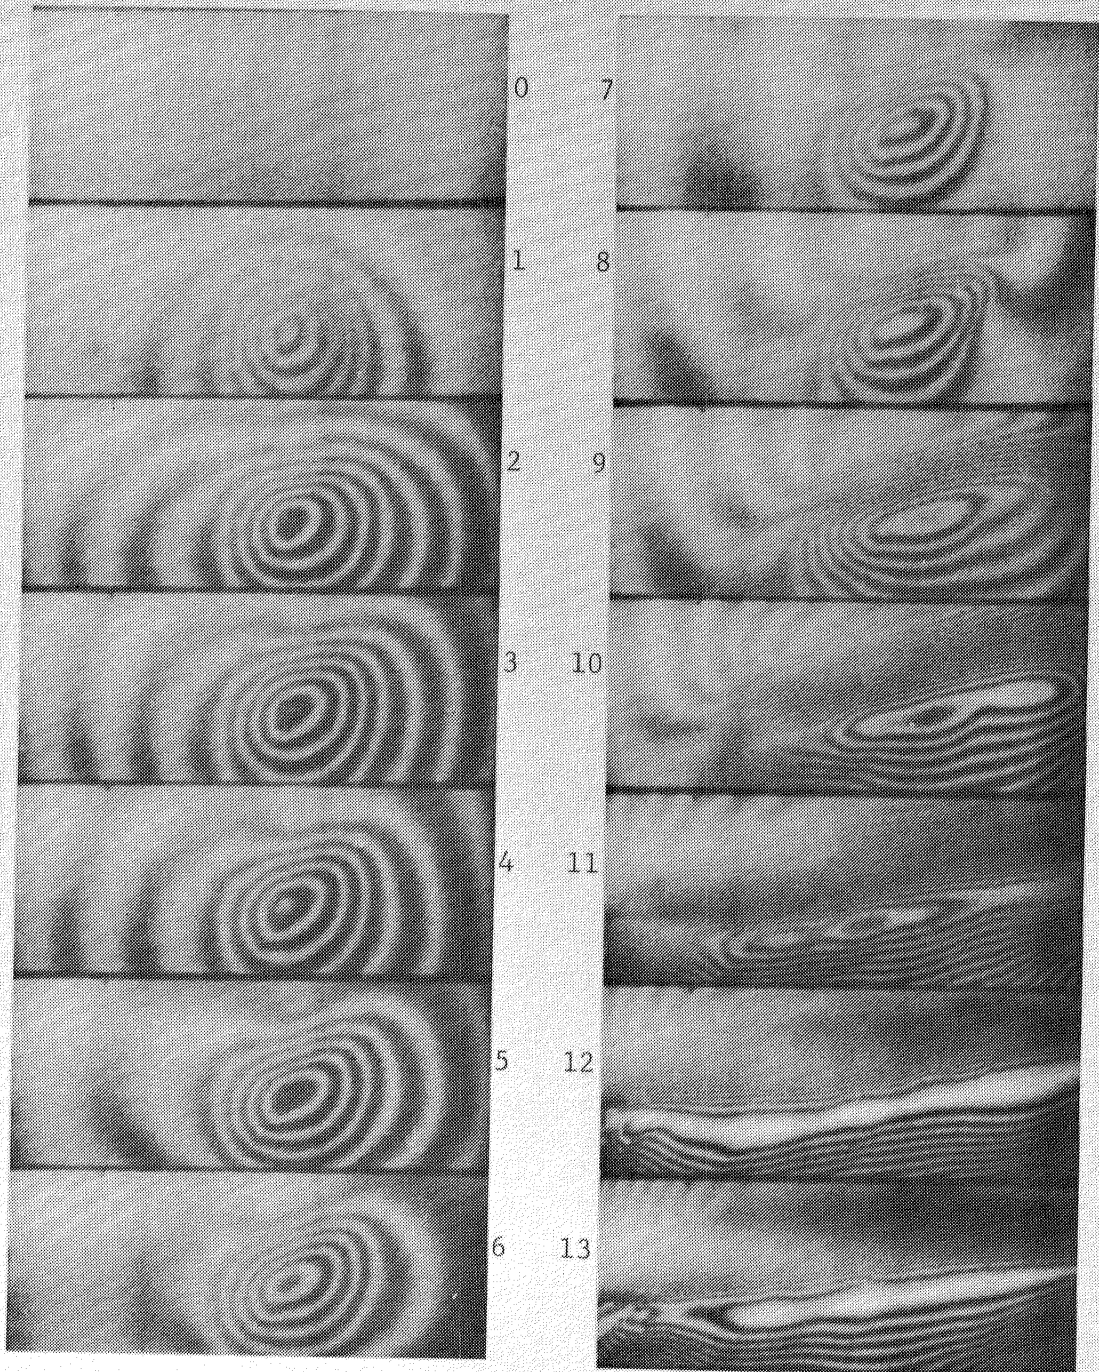
The results for panel B-2 are shown in fig. 8. The impact point is not centered in the picture. The field of

view is 86 x 29 mm and the time between frames is 61  $\mu$ s. The impact causes a peak displacement on the back surface of the order of 1 mm. This displacement changes very little for six frames ( $\approx 360$   $\mu$ s) indicating that it represents permanent deformation. Frame 8 shows a rapid growth which is interpreted to be bulging of the outer laminates of the panel. The growth appears to start at a slight angle to the horizontal. This pattern of growth was observed in some but not all subsequent tests. The most distinguishing feature of this sequence of photographs is the delay between the initial damage phase and the subsequent damage propagation phase. This feature will be discussed further in this report.

Another observation of interest has to do with the time at which the damage spreads after initial impact has occurred. In this connection it is well to remember that most of the experiments were conducted in the vicinity of projectile velocity of 60-70 m/sec. According to fig. 6, this falls into the steeper portion of the curve relating failure strain to projectile velocity. For most of the experiments it was quite clear that damage in the form of a displacement peak under the impact point occurred very rapidly but the damage did not spread immediately. For example, in fig. 11 it took something like 24 frames or the equivalent of 1.2 ms before the damage started to grow significantly. After it started to grow, the growth was relatively rapid. Again, by comparison fig. 8 shows that damage did not appear to grow for

approximately eight frames or the equivalent of 0.5 ms and then grew very rapidly. Finally, from fig. 9 it is evident that damage grew almost from the very beginning of impact. While it may on cursory examination appear that there may be two modes under which damage spreads it is believed that this is related to the strain level. Panels that are closer to the threshold curve tend to have an early propagation of the damage area while those further away exhibit a slight delay of propagation.

Fig. 8 Test Panel B-2, 16,500 frames/sec.

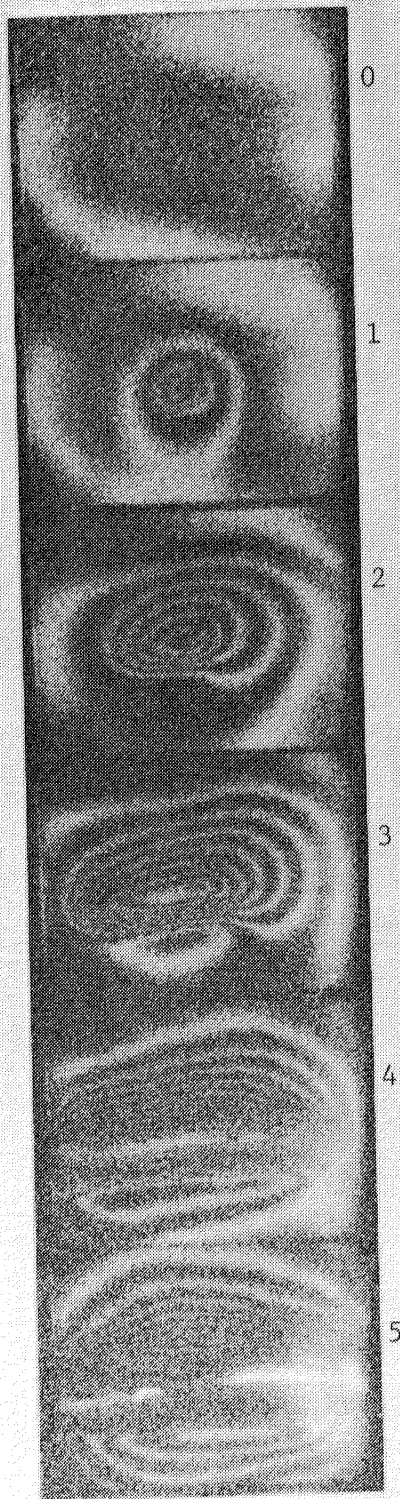
The results for test panels B-6 and B-9 are shown in figs. 9 and 10. These photographs show larger fields of view than that for B-2. The sequence of events is much the same as before but the time delay is different. B-6 (fig. 9) shows a delay of less than 50  $\mu$ s (the time between frames) while B-9 exhibits a slow growth for about 200  $\mu$ s, followed by a large deformation of the back surface.

Fig. 9 Test Panel B-6, 20,000 frames/sec.

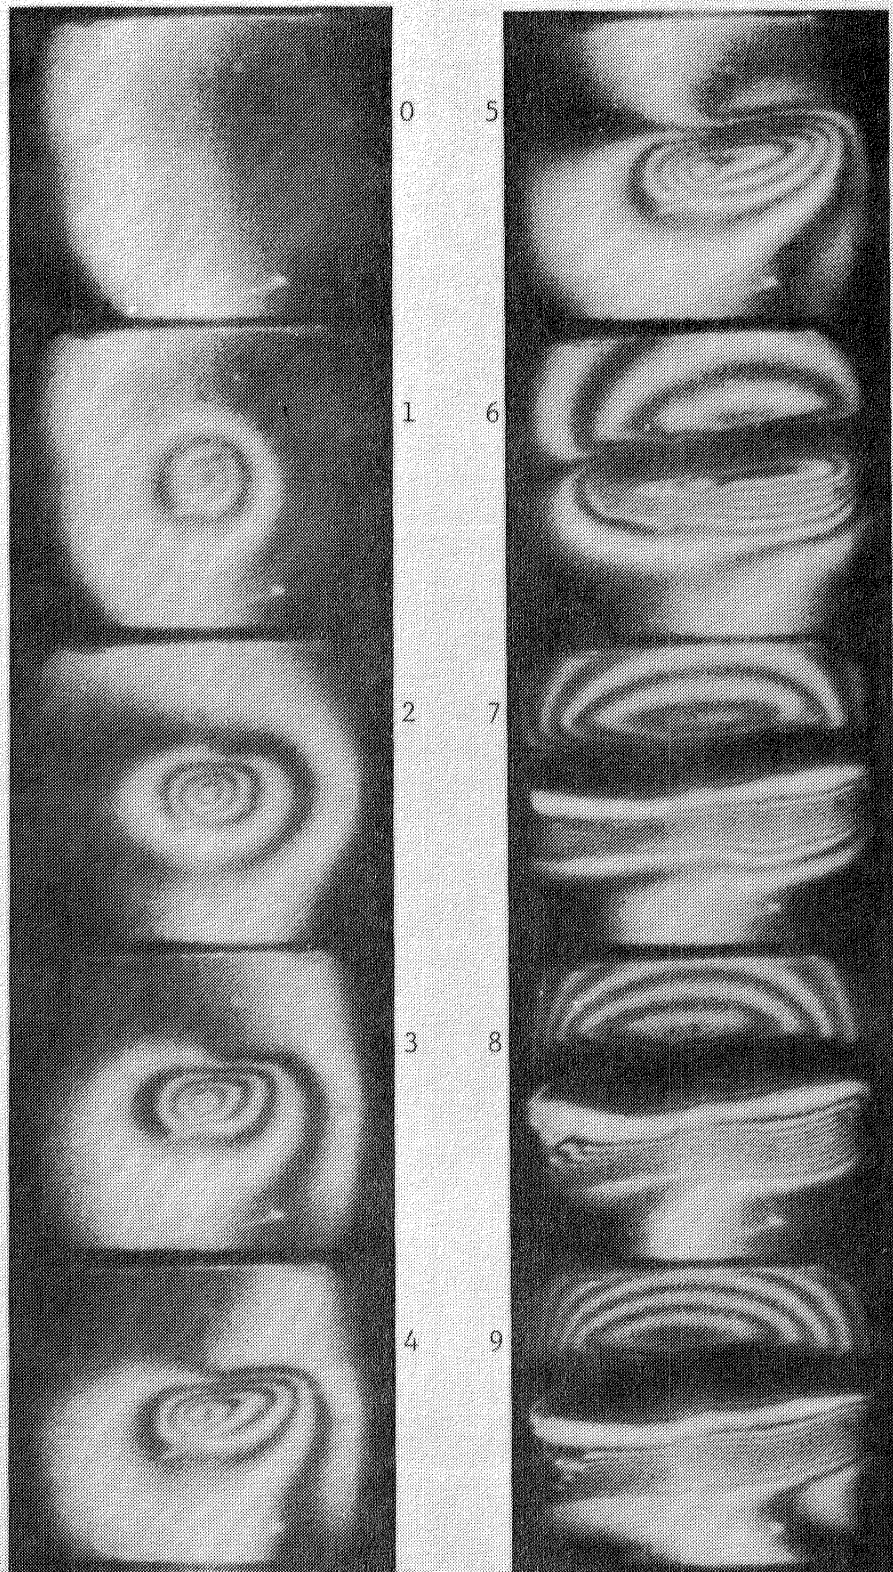
Fig. 10 Test Panel B-9, 19,900 frames/sec.

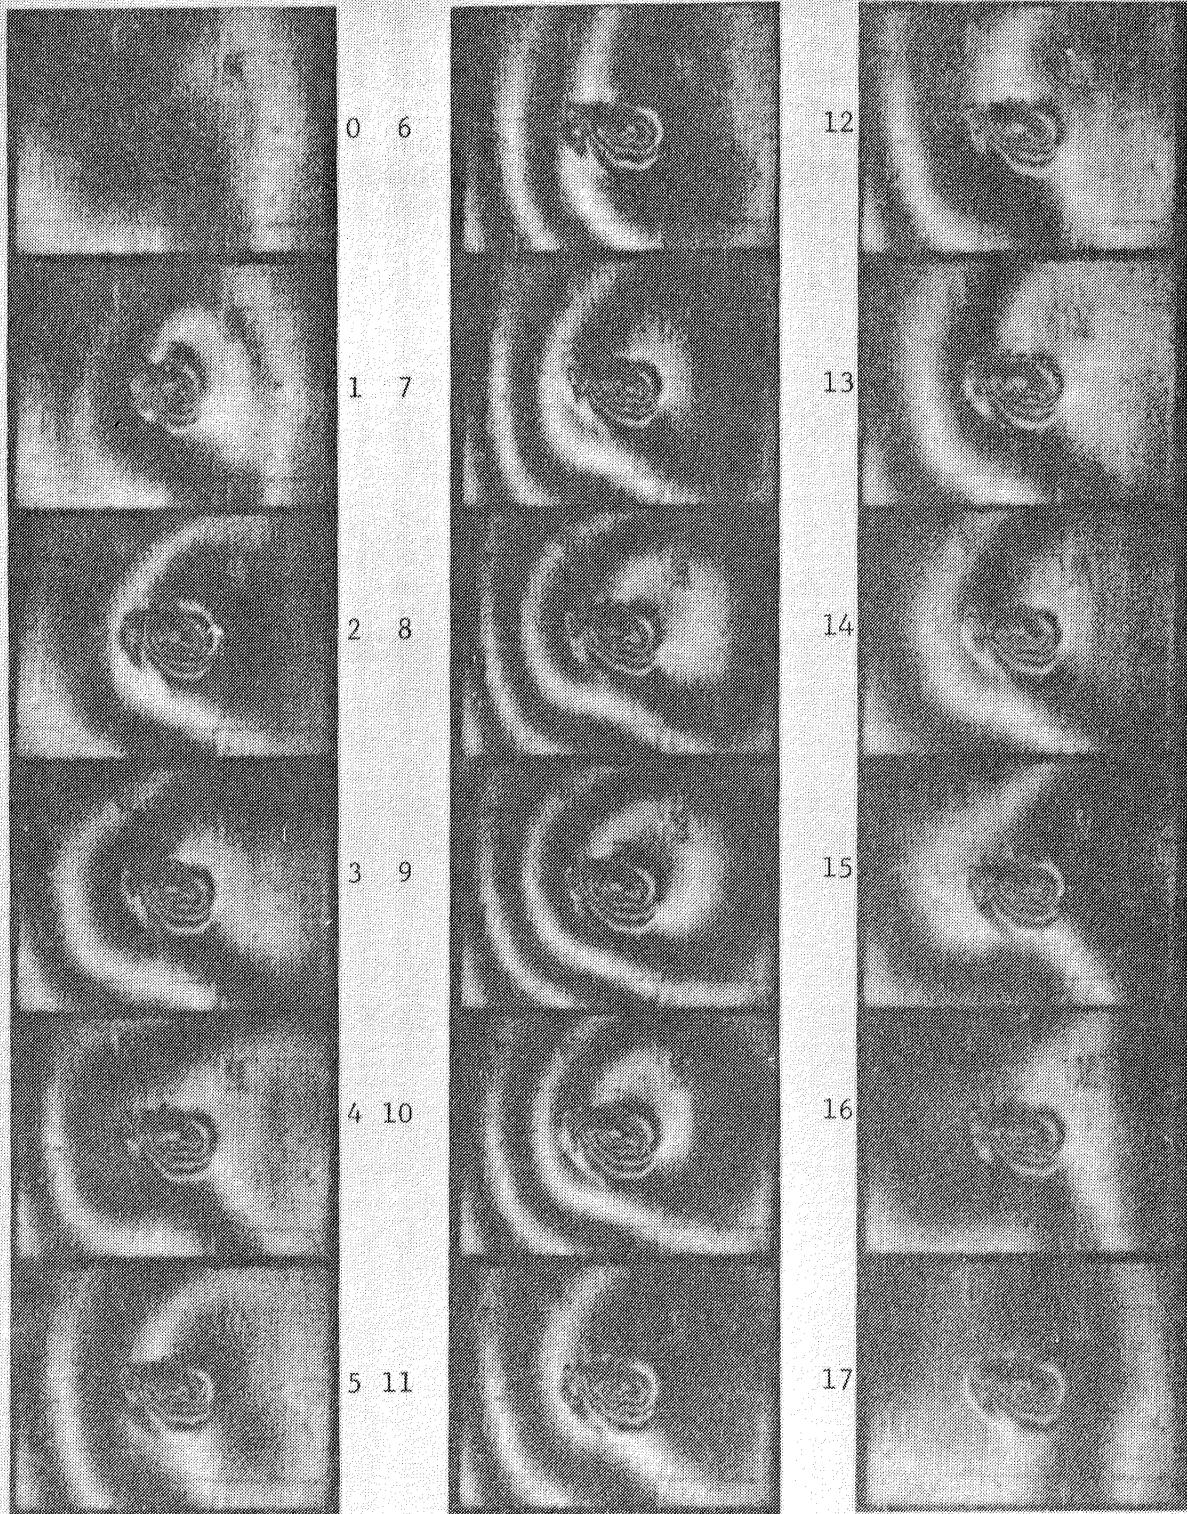
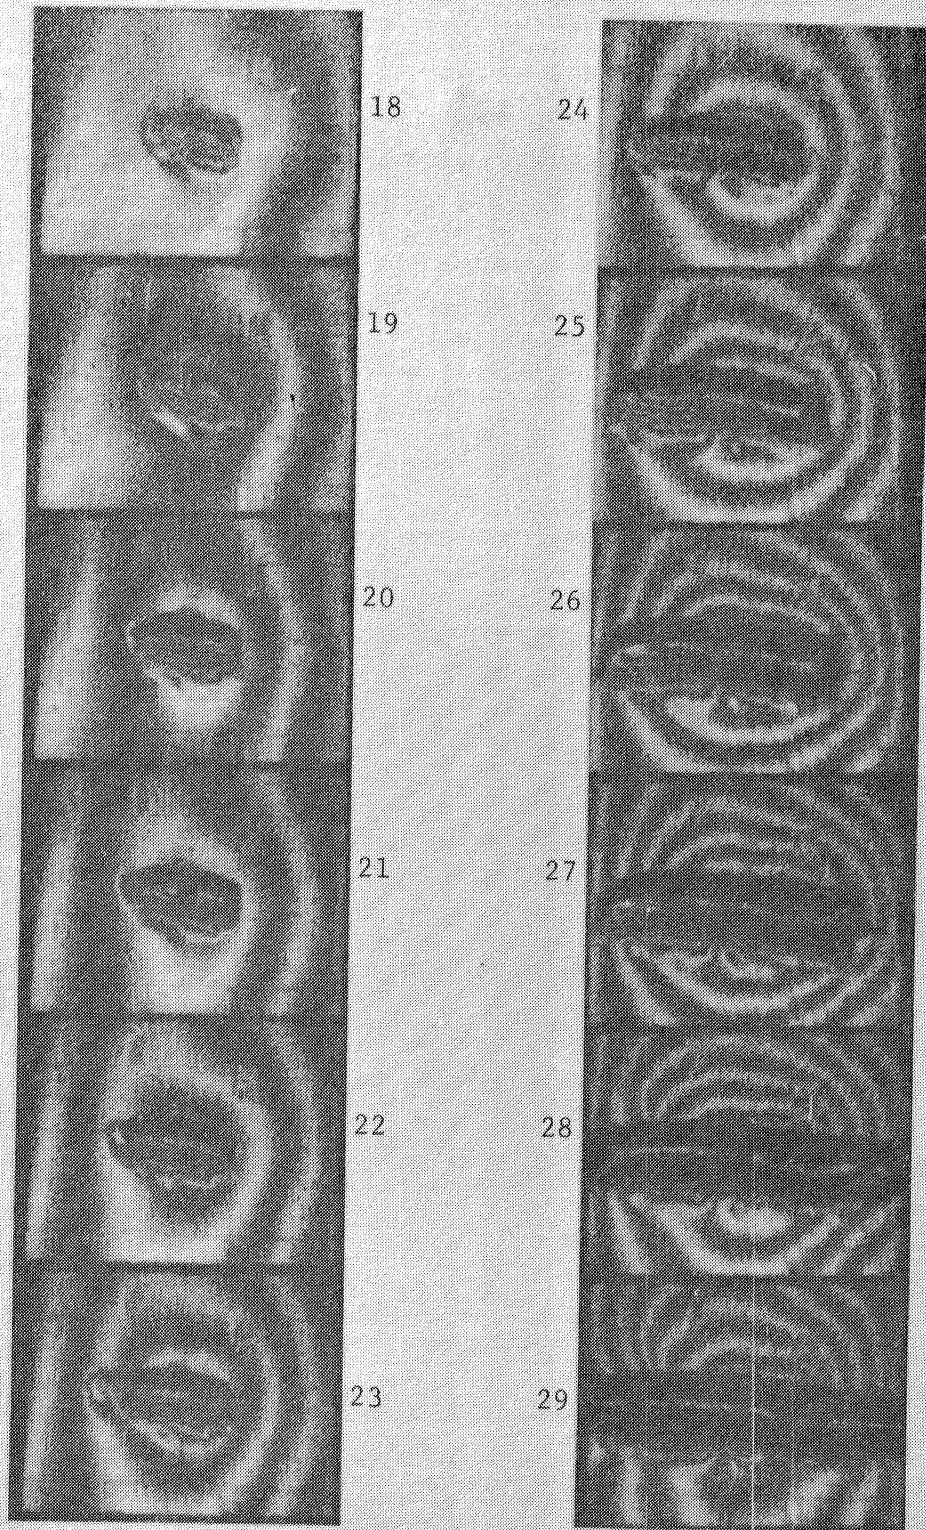
Figure 11 shows the moiré photographs for test panel C-2. This panel is larger than those previously discussed (254 x 152 mm vs. 203 x 101 mm). The fringe quality is not particularly good for this series of photographs but the sequence of events can be detected. The rapid growth of the damage area does not begin until frame 24 (1200  $\mu$ s). Prior to this the damage area is almost stationary with a slow

growth beginning in frame 17. Superimposed on this "permanent" deformation is what appears to be a plate vibration motion. The half period (ending in frame 16) corresponds to a frequency of about 600 Hz.

Fig. 11 Test Panel C-2, 19,000 frames/sec.

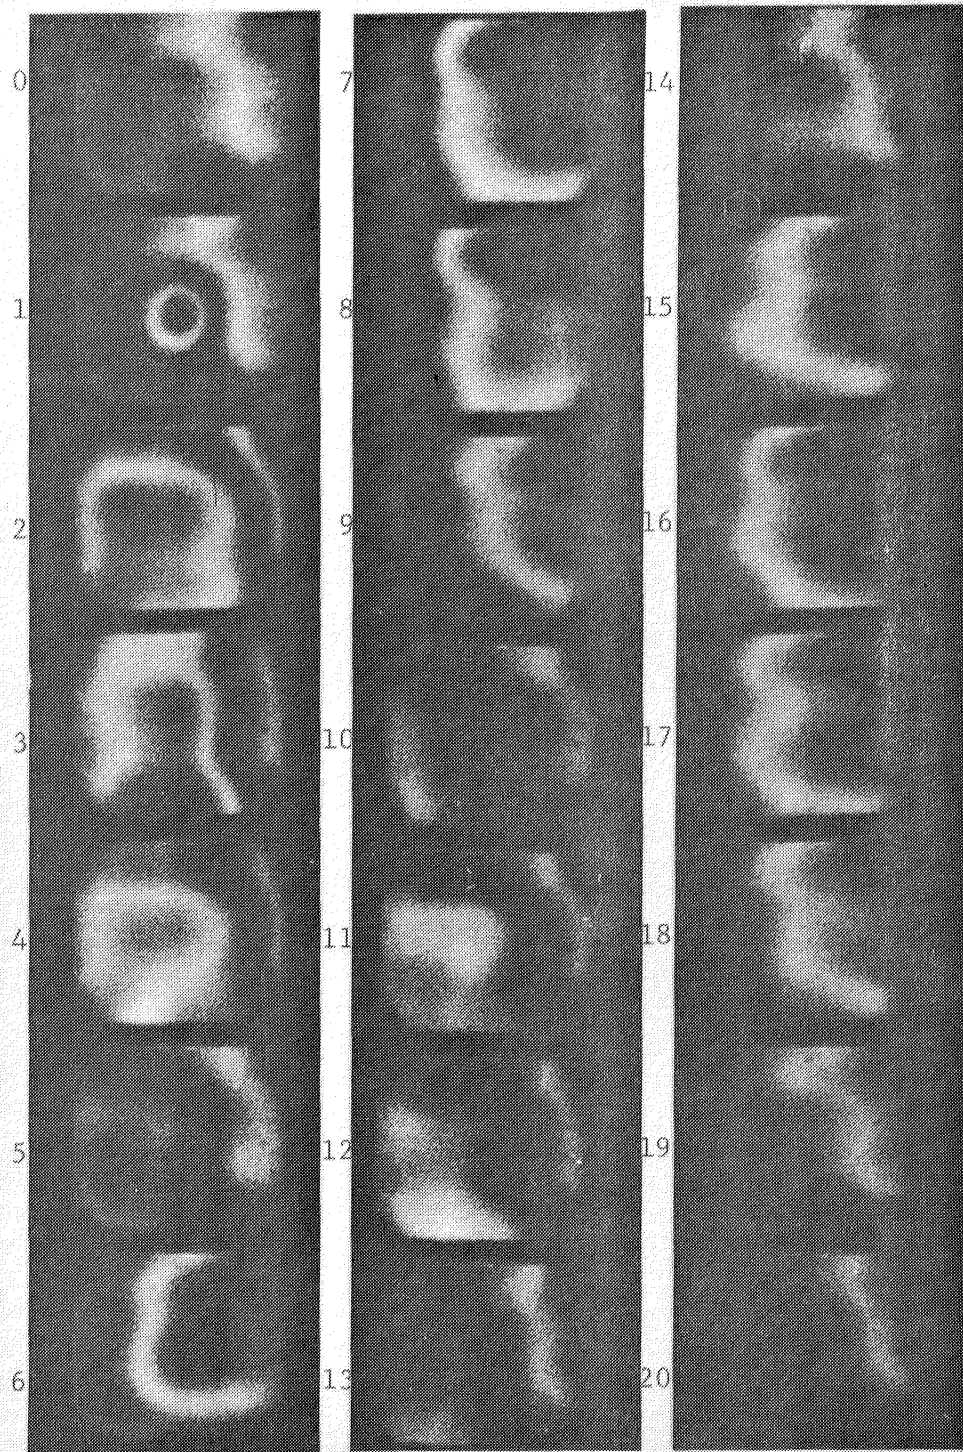
A photo sequence of an unloaded test panel (B-5) is shown in fig. 12. The maximum surface displacement observed was about 0.25 mm. No permanent deformation was observed from the moiré photograph.

Fig. 12 Test Panel B-5, 20,000 frames/sec.

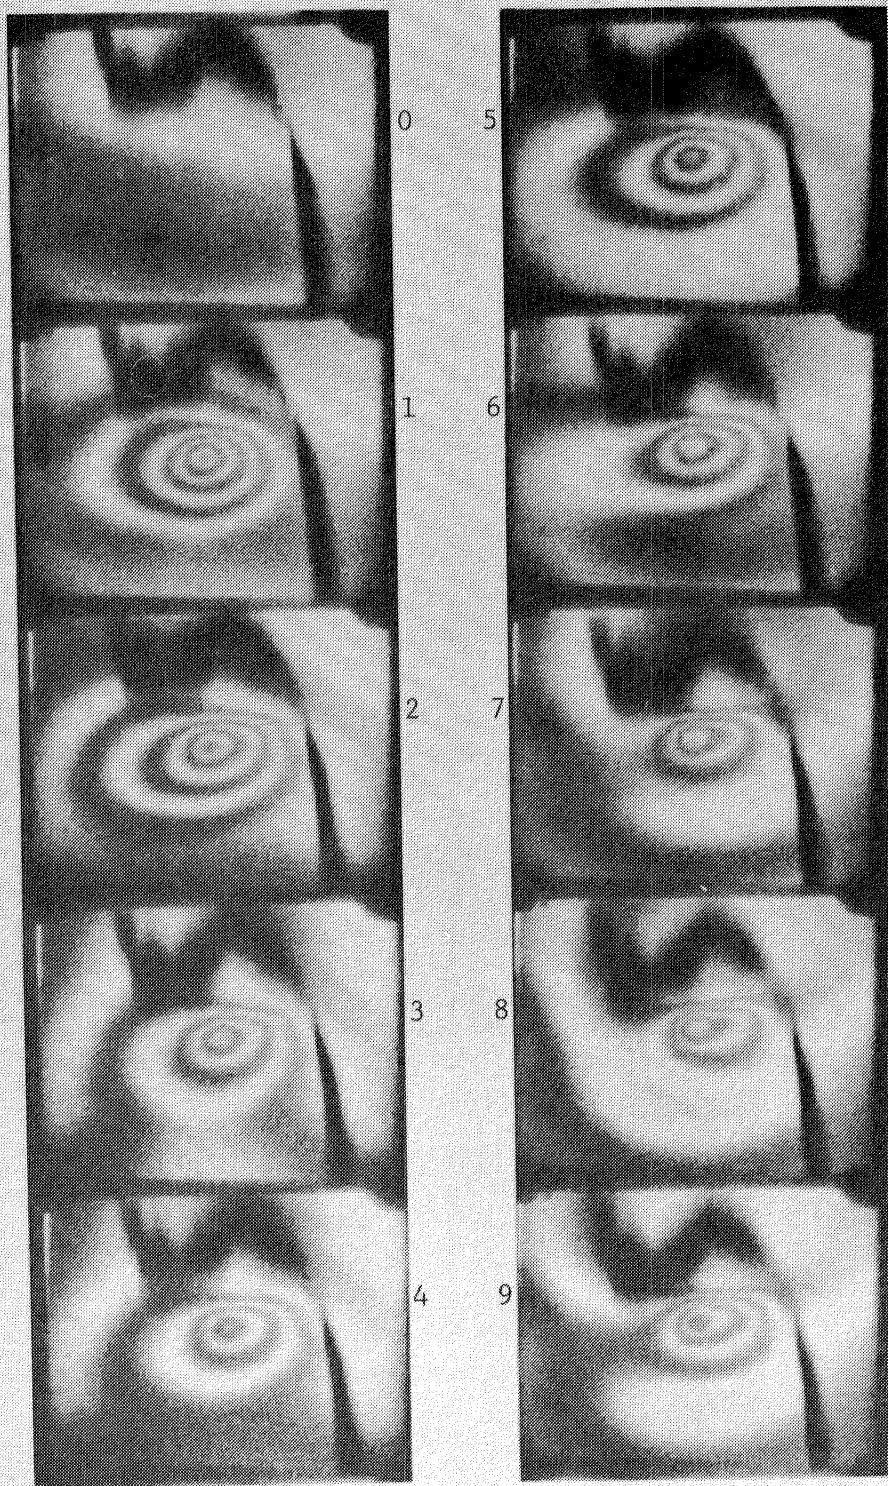
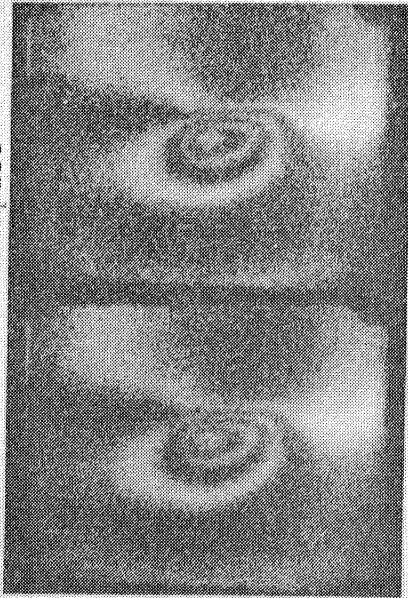
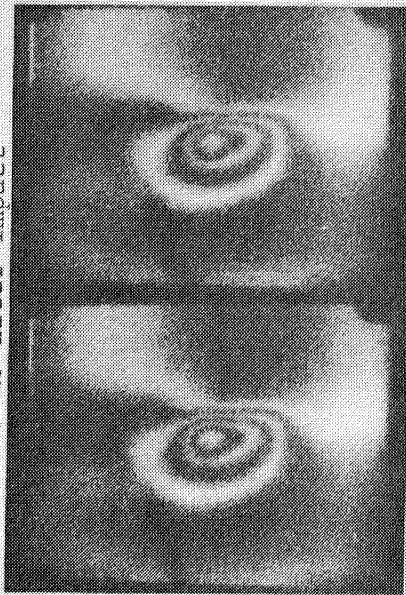
The photographs for test panel B-4 are shown in fig. 13. The irregular dark pattern in this series of photographs is due to an optical interference. This panel was impacted at the same velocity as B-5 but was preloaded to a strain of 3180  $\mu\text{m}/\text{m}$ . Catastrophic failure did not occur until approximately one minute after impact. The back surface permanent deformation was about 0.8 mm out of a total deformation of about 1.3 mm. Comparing this result to that of B-5 indicates some coupling of the in-plane load and the impact.

Fig. 13 Test Panel B-4, 21,000 frames/sec.

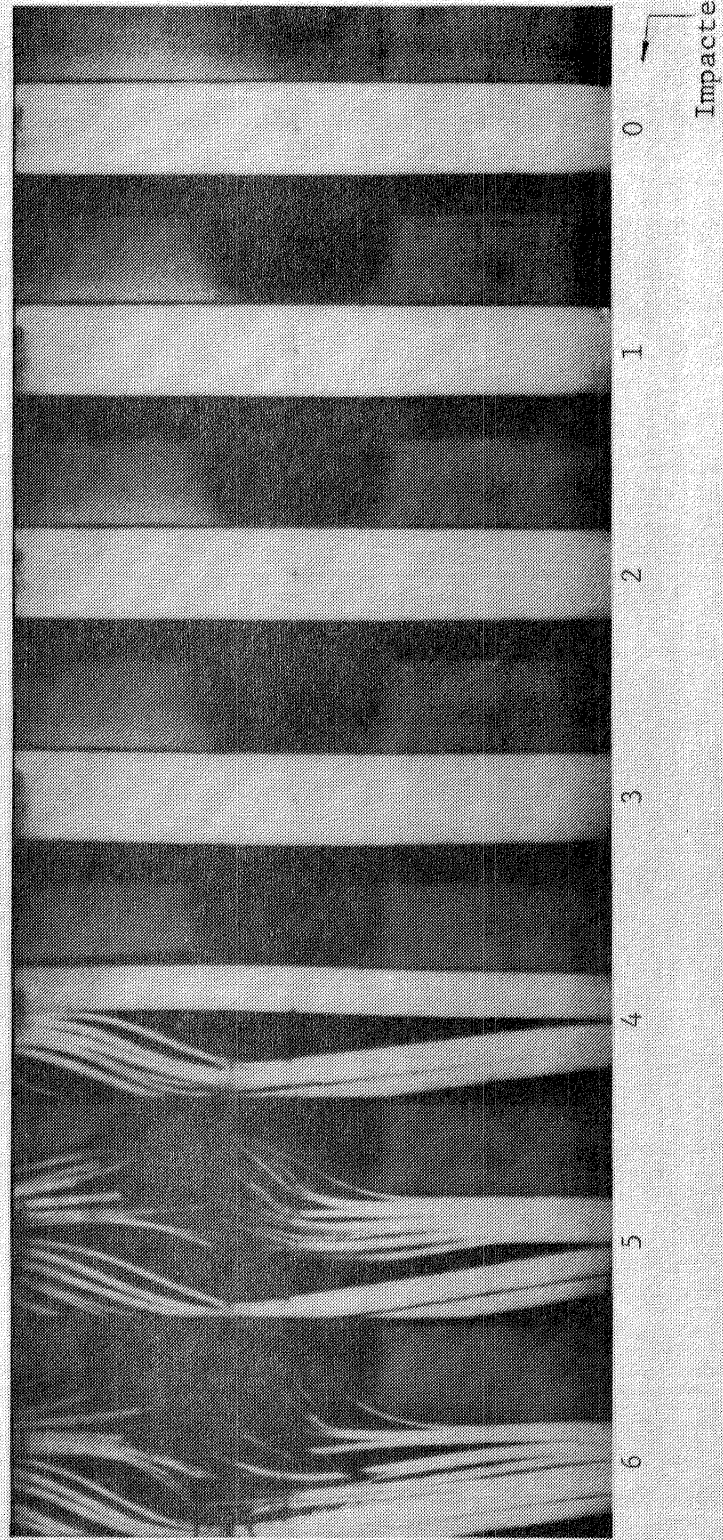
Several test panels were impacted and the side of the specimen photographed. These results are shown in fig. 14 for test panel A-3. The test panel is unsupported over the field of view shown in the film sequence. Frame 0 shows the projectile advancing towards the specimen. Impact was estimated to occur 45  $\mu\text{s}$  after frame 0. Frame 2 shows a central crack extending the whole width of the photograph (85  $\mu\text{s}$  after impact). The plate edge moves approximately 0.25 mm in frame 3. Additional cracks (delaminations) occur

in subsequent frames accompanied by front and rear surface buckling and complete rupture of the panel. This sequence of photographs (highlighted by the early appearance of an edge crack) led to similar tests on two other panels (AB-1, AB-3).

Fig. 14 Test Panel A-3, 15,500 frames/sec. (The portion of the test panel shown is free from support.)

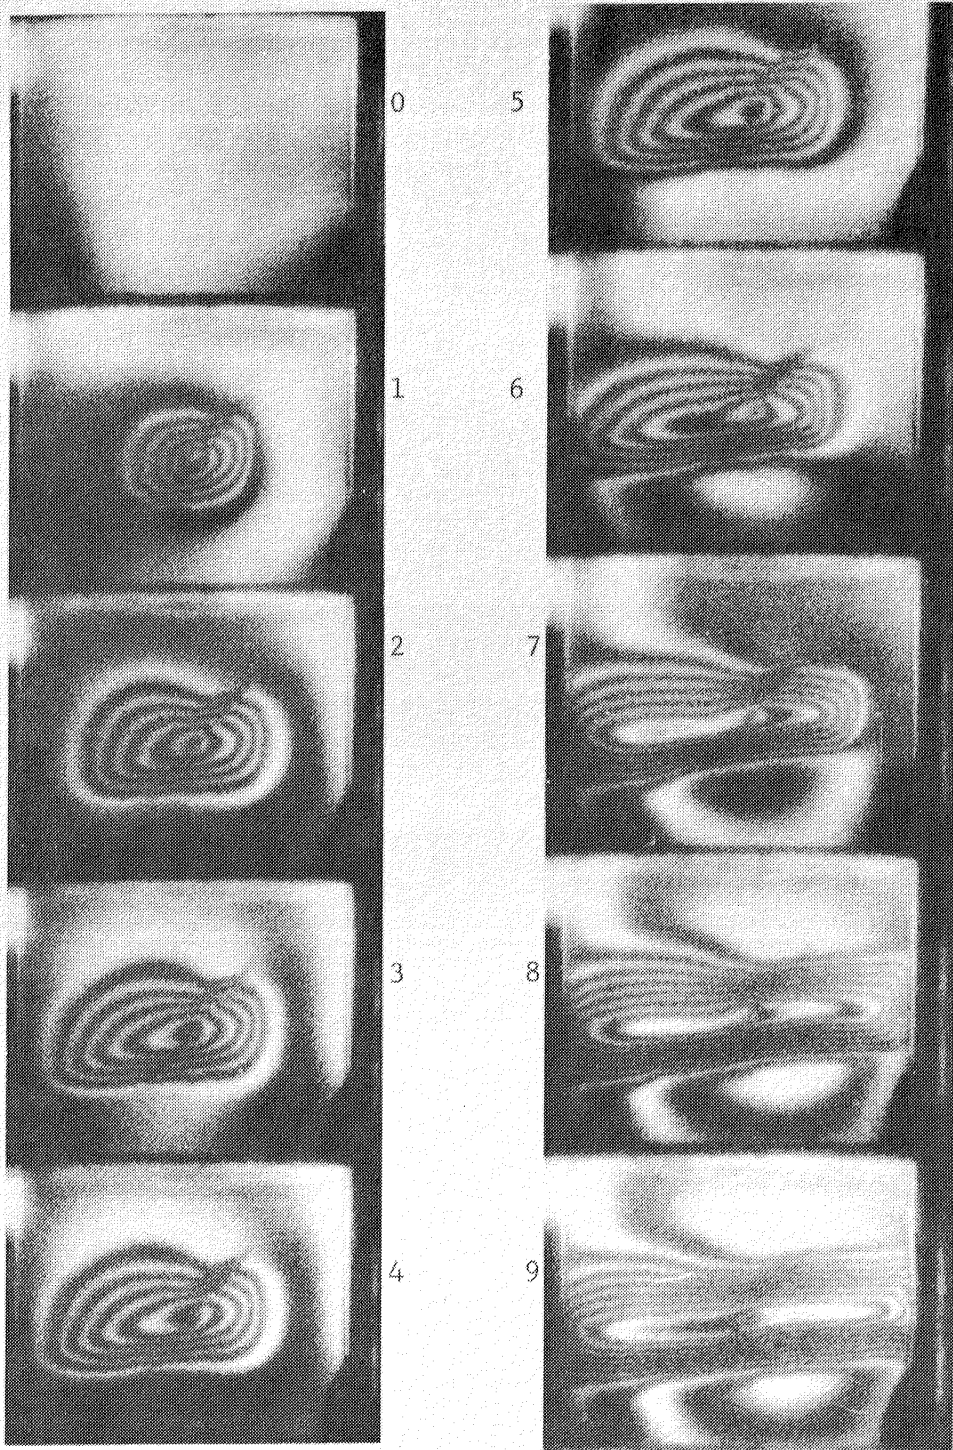
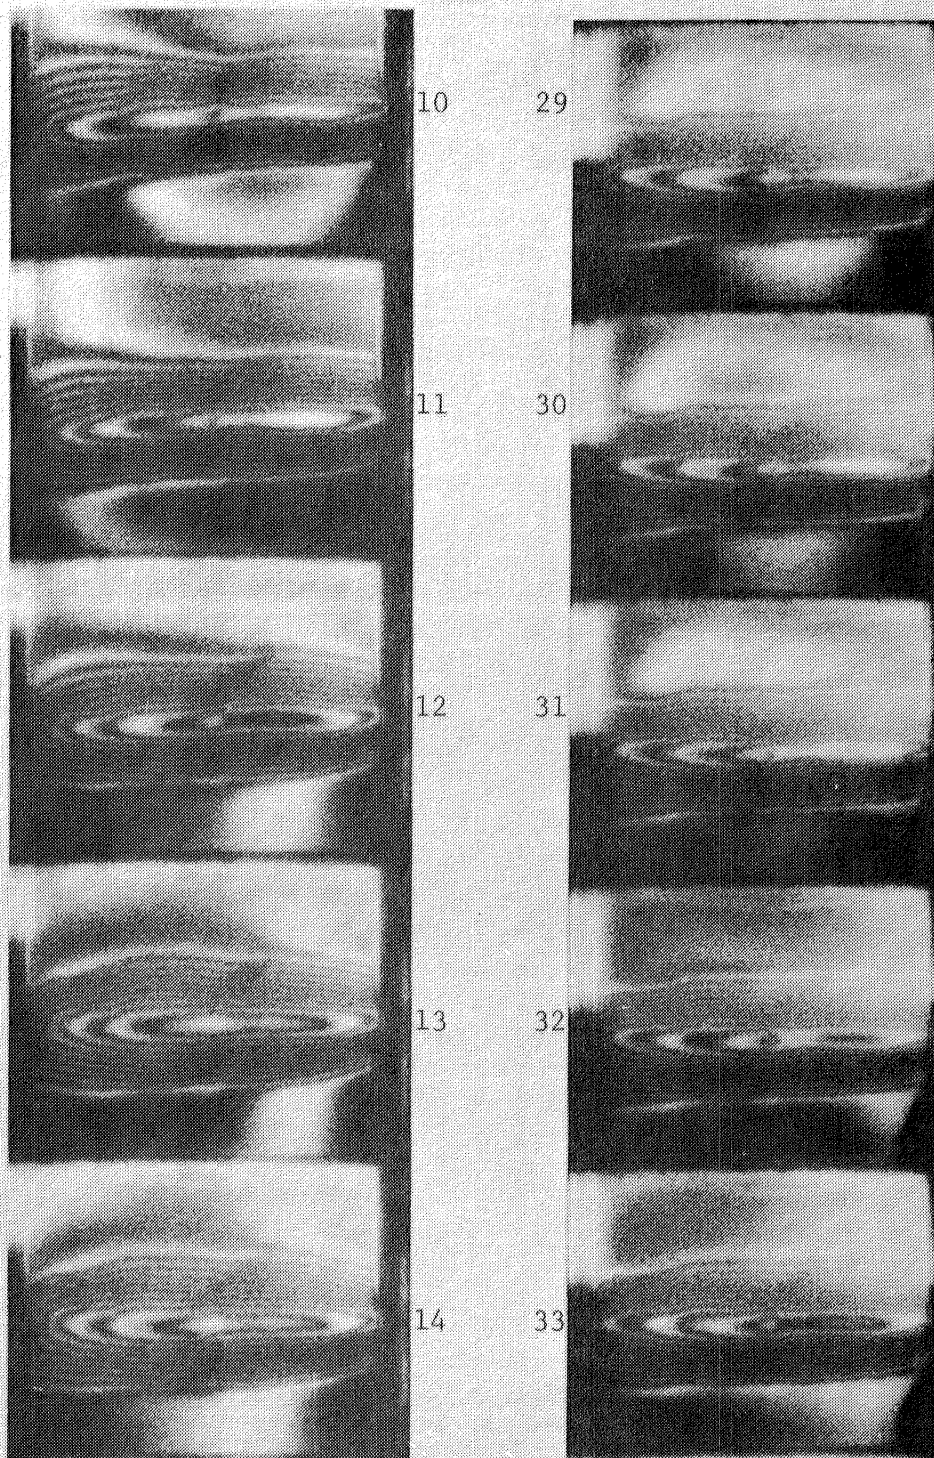
Test specimen AB-1 was supported with the small specimen support. A window along the side of the support was cut so that a side view photograph could be made. The panel was supported along its entire length. The moiré pattern obtained for test AB-1 is shown in fig. 15a and the side view is shown in fig. 15b (corresponding to the left side of fig. 15a). Based on the common timing pulse, it was found that frame 0' (side view) is 14  $\mu$ s later than frame 0. The characteristic deformation propagated along the specimen width and reached the left side boundary in frame 6. Note that its tip is pointed down about 7 mm. Frame 6' (14  $\mu$ s later than 6) shows an initial appearance of a central crack. In frame 7' the crack has extended through the full length of the pictures. This was accompanied by the appearance of a larger crack (5 mm long) pointed downward from the impact level (central

spot). The short crack appearance is attributed to the deformation recorded in frame 6. Frames 29' to 31' show the complete failure of the test specimen.

to observe its edge. It is clear by looking at the edgewise photograph of the plate (fig. 15b) that the first crack appears at the edge at roughly the time at which in the other picture (fig. 15a) the moiré pattern has reached the left boundary of the plate. As a result of this experiment the front of the internal propagating delamination has been associated with the first or lowest order fringe in the moiré pattern. This assignment of the propagation front is a bit arbitrary; however, for the present purposes of an engineering interpretation of the phenomenon occurring in the damage progression it seemed quite sufficient. Further examination of the propagating damage will use this definition for the extent of the damage region.

Fig. 15a. Test Panel AB-1, 19,800 frames/sec.

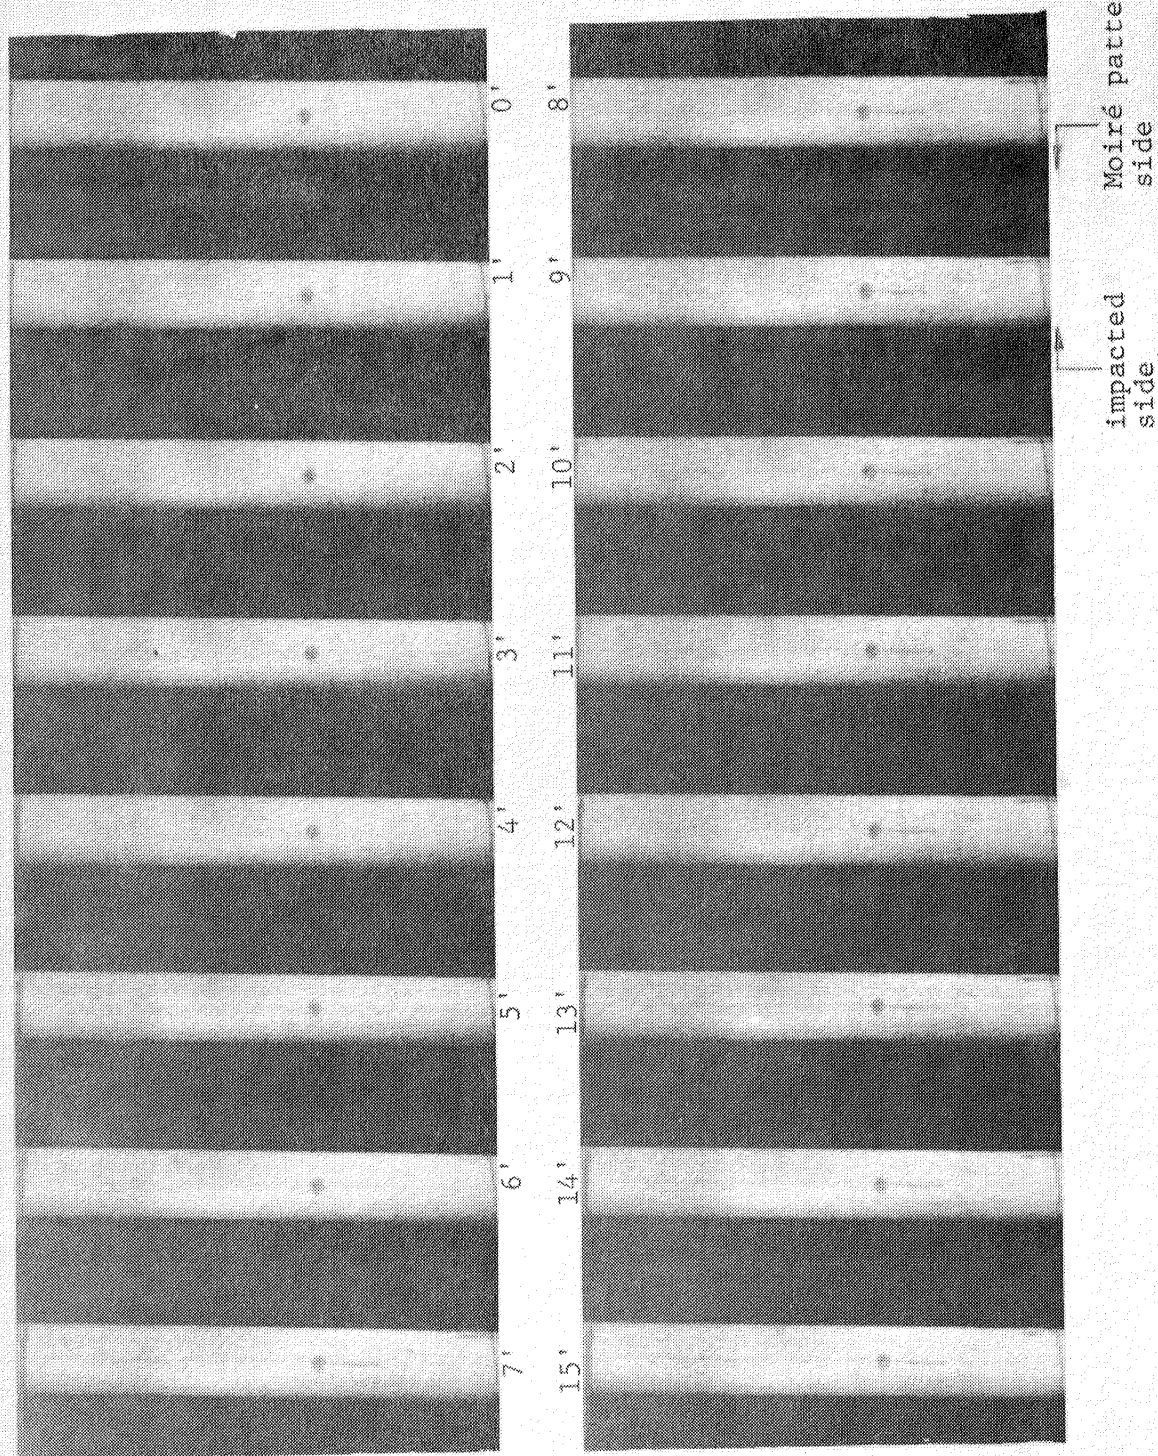
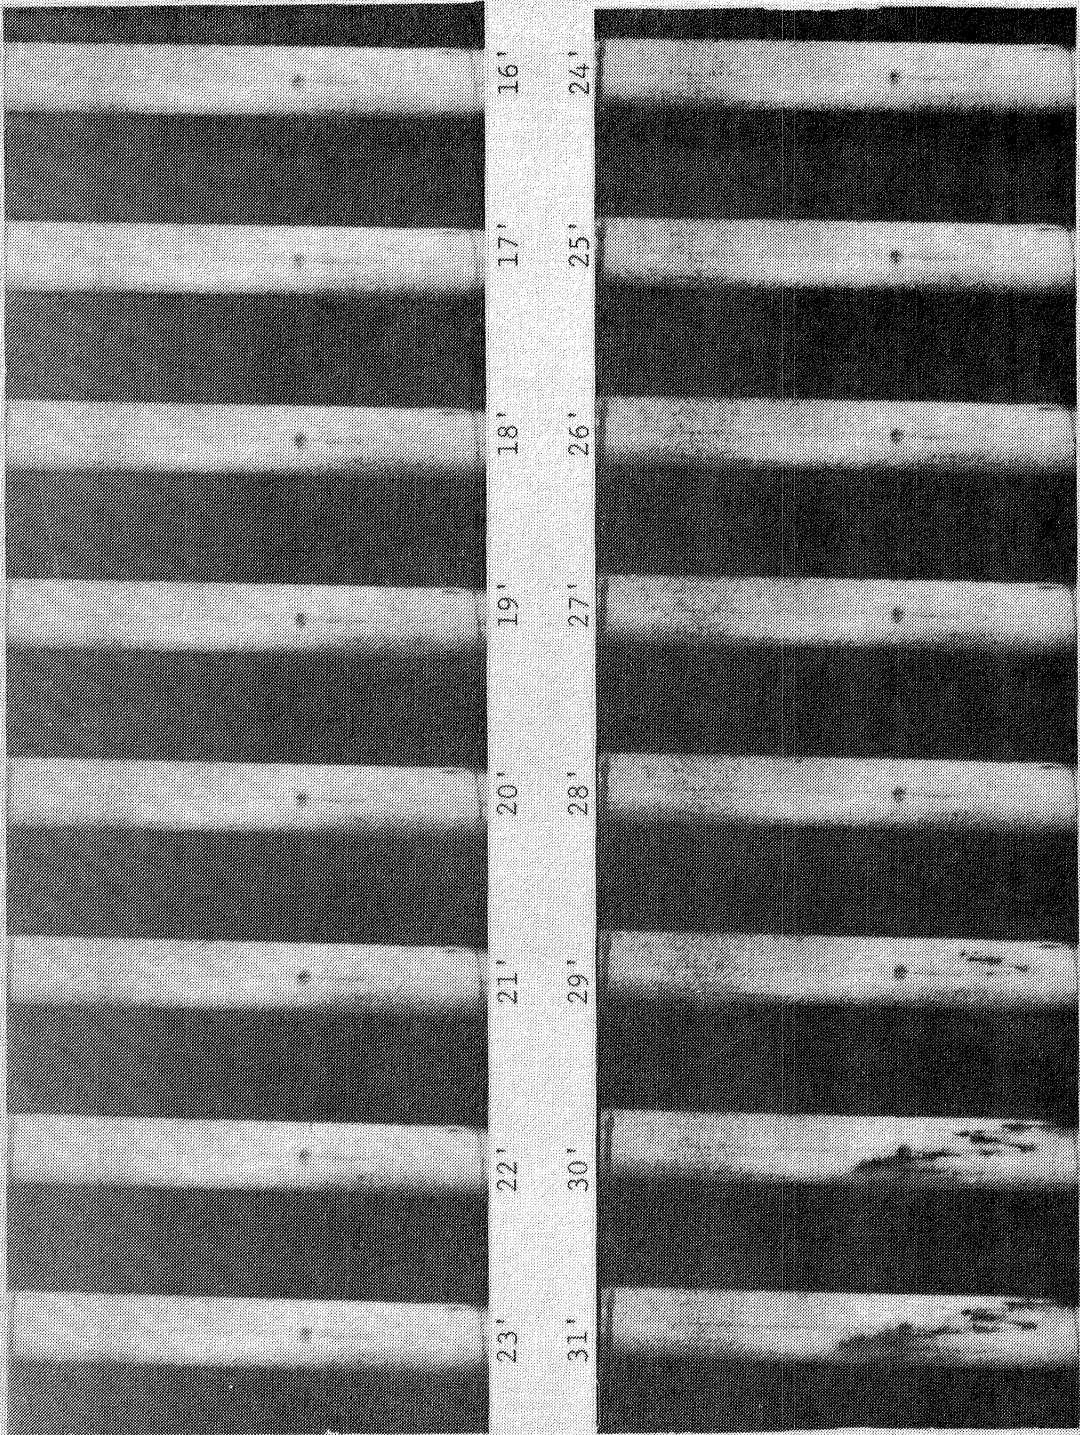
Having tentatively established so far when and how rapidly the delamination propagates it is appropriate to comment on the final stages of the compression failure. In fig. 15b, the edge view of a specimen is recorded. The point where a single central crack has appeared and further damage results in a gross fashion occurs in the frames after and including frame 29'. The time corresponding to frame 30' is about 1.5 ms after impact. There are two reasons why this final failure phenomenon may occur at this time. First, since the natural frequency of vibration is on the order of 2000 Hz, the phenomenon might possibly be related

Fig. 15b Test Panel AB-1, 18,150 frames/sec.

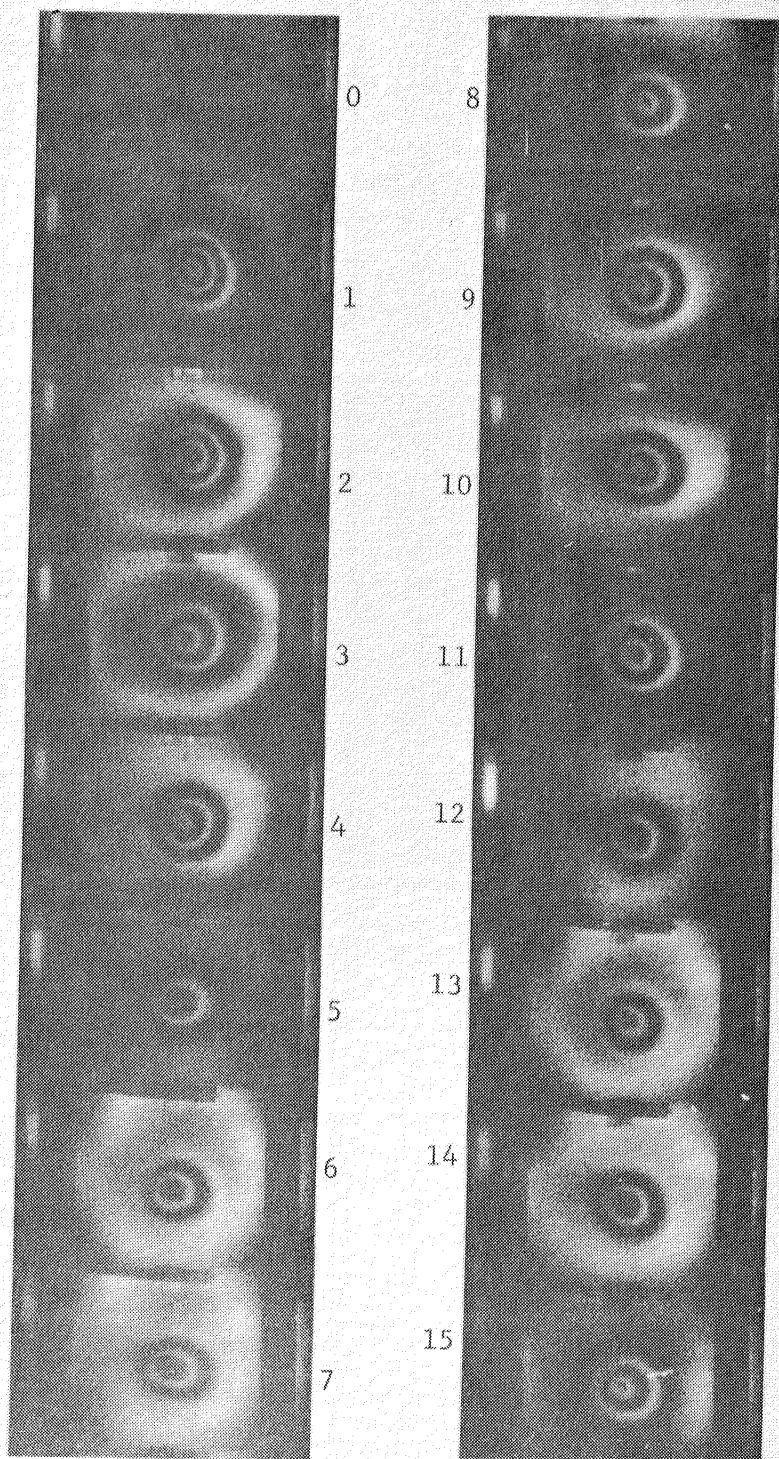
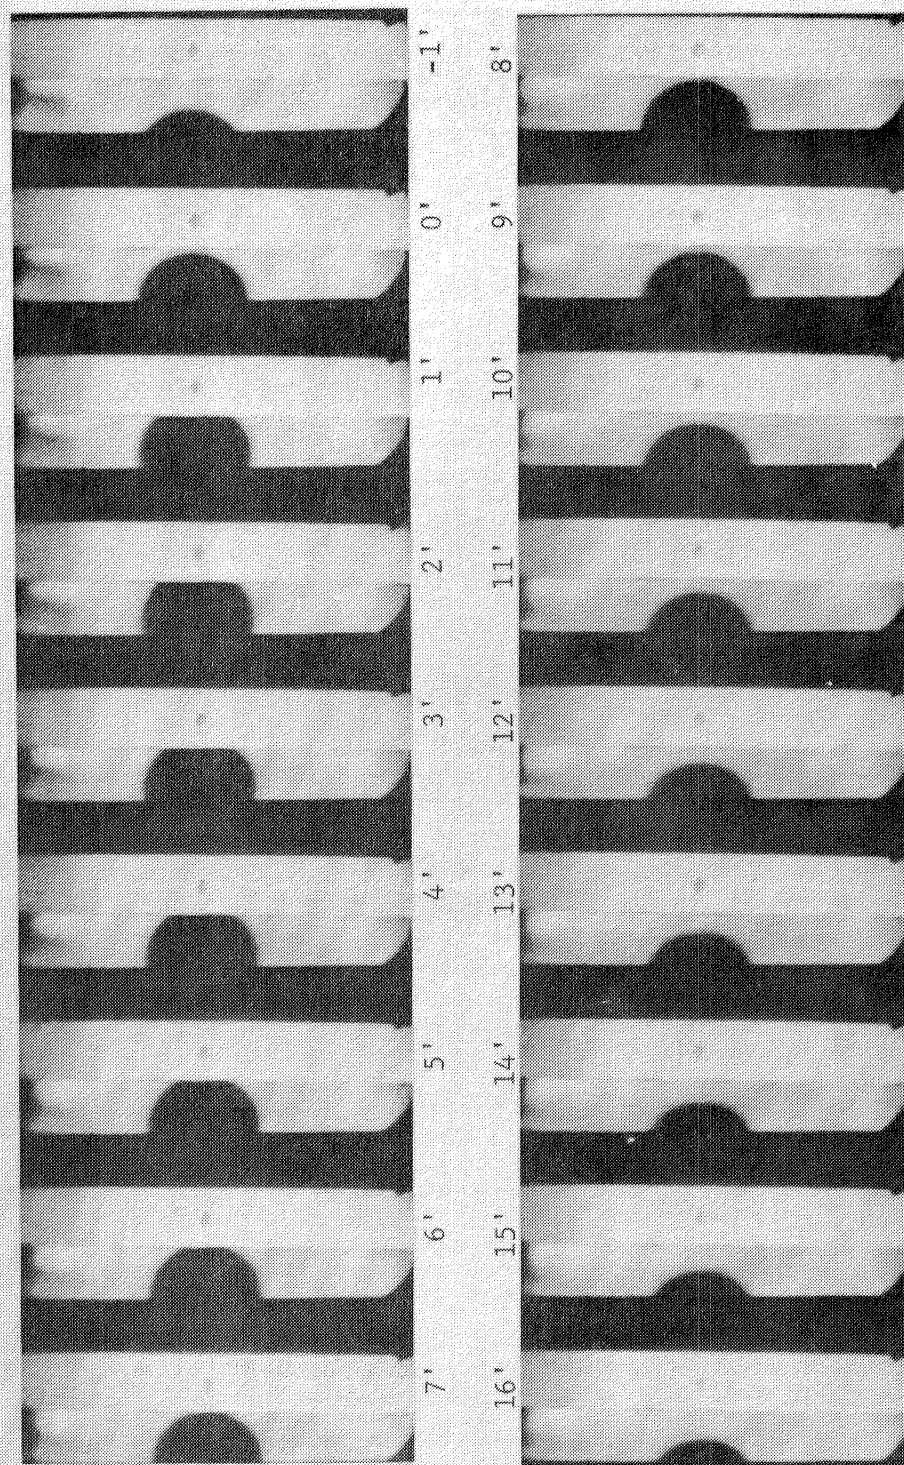
Test panel AB-3 was trimmed to its size from a large specimen type of lot number 2. The photographic results are given in figs. 16a and 16b. Frame 0' was calculated to be 30  $\mu$ s before impact and 28  $\mu$ s after frame 0. This test panel did not fail catastrophically and there is no evidence of any edge cracks. A permanent surface displacement of the order of 0.6 mm is visible in fig. 16a. The impact duration and rebound velocity were found to be 70  $\mu$ s and 7 m/sec from fig. 16b.

Fig. 16a Test Panel AB-3, 18,400 frames/sec

Fig. 16b Test Panel AB-3, 19,800 frames/sec.
